Re: Sahuarita Heights Flooding - Delgado Watershed Area Study and Evaluation

SUBJECT: Sahuarita Height Flooding - Delgado Watershed Area

Delgado Road Area Flooding Concerns

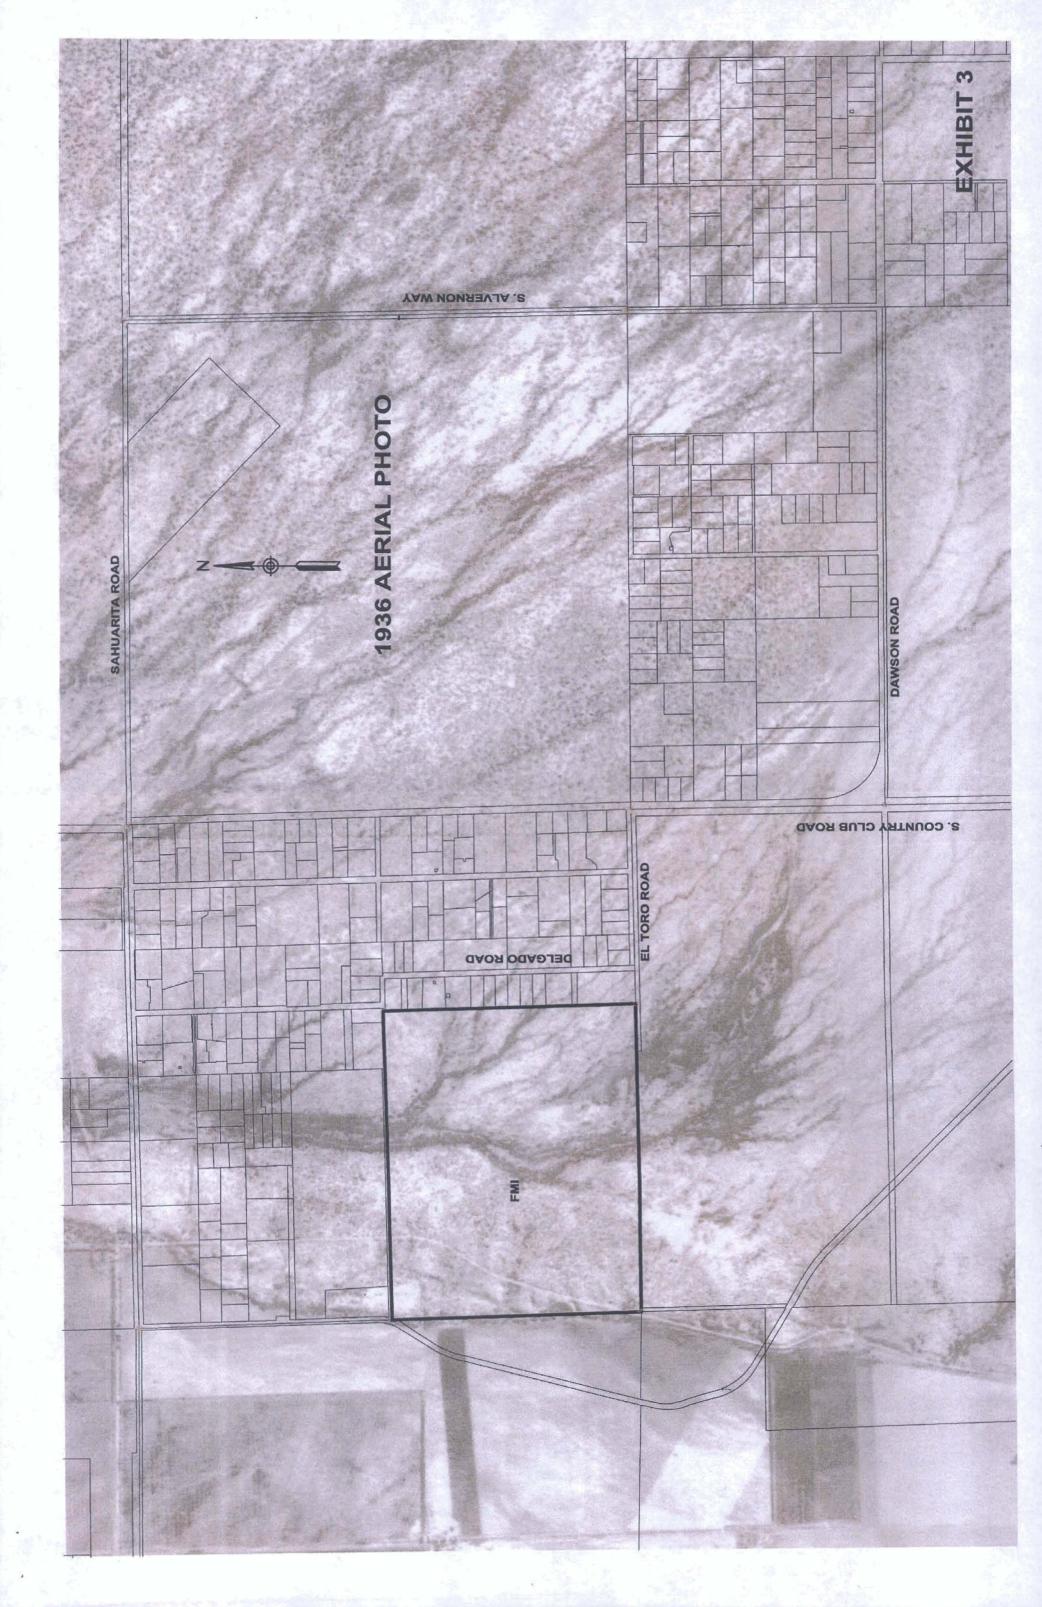
In order to assess the development history of the area, a series of aerial photographs were obtained and examined. Those photographs are presented as **Exhibits 3 through 6. Exhibit 3** is the earliest available photograph for the area from 1936 and best illustrates the subject area before any residential development had occurred. For reference purposes, the present lot lines and current road alignments are super-imposed on this photograph. The photograph illustrates farming west of the subject area and some existing drainage diversions kicking flow to the north to protect those farm fields although most of the subject area appears undisturbed. Also evident is the distributory flow pattern throughout the subject area with relatively dense vegetation, as illustrated by the dark portions of the photo, indicative of a main drainage conveying flow (only later to be truncated by additional farm berms) through the present FMI property.

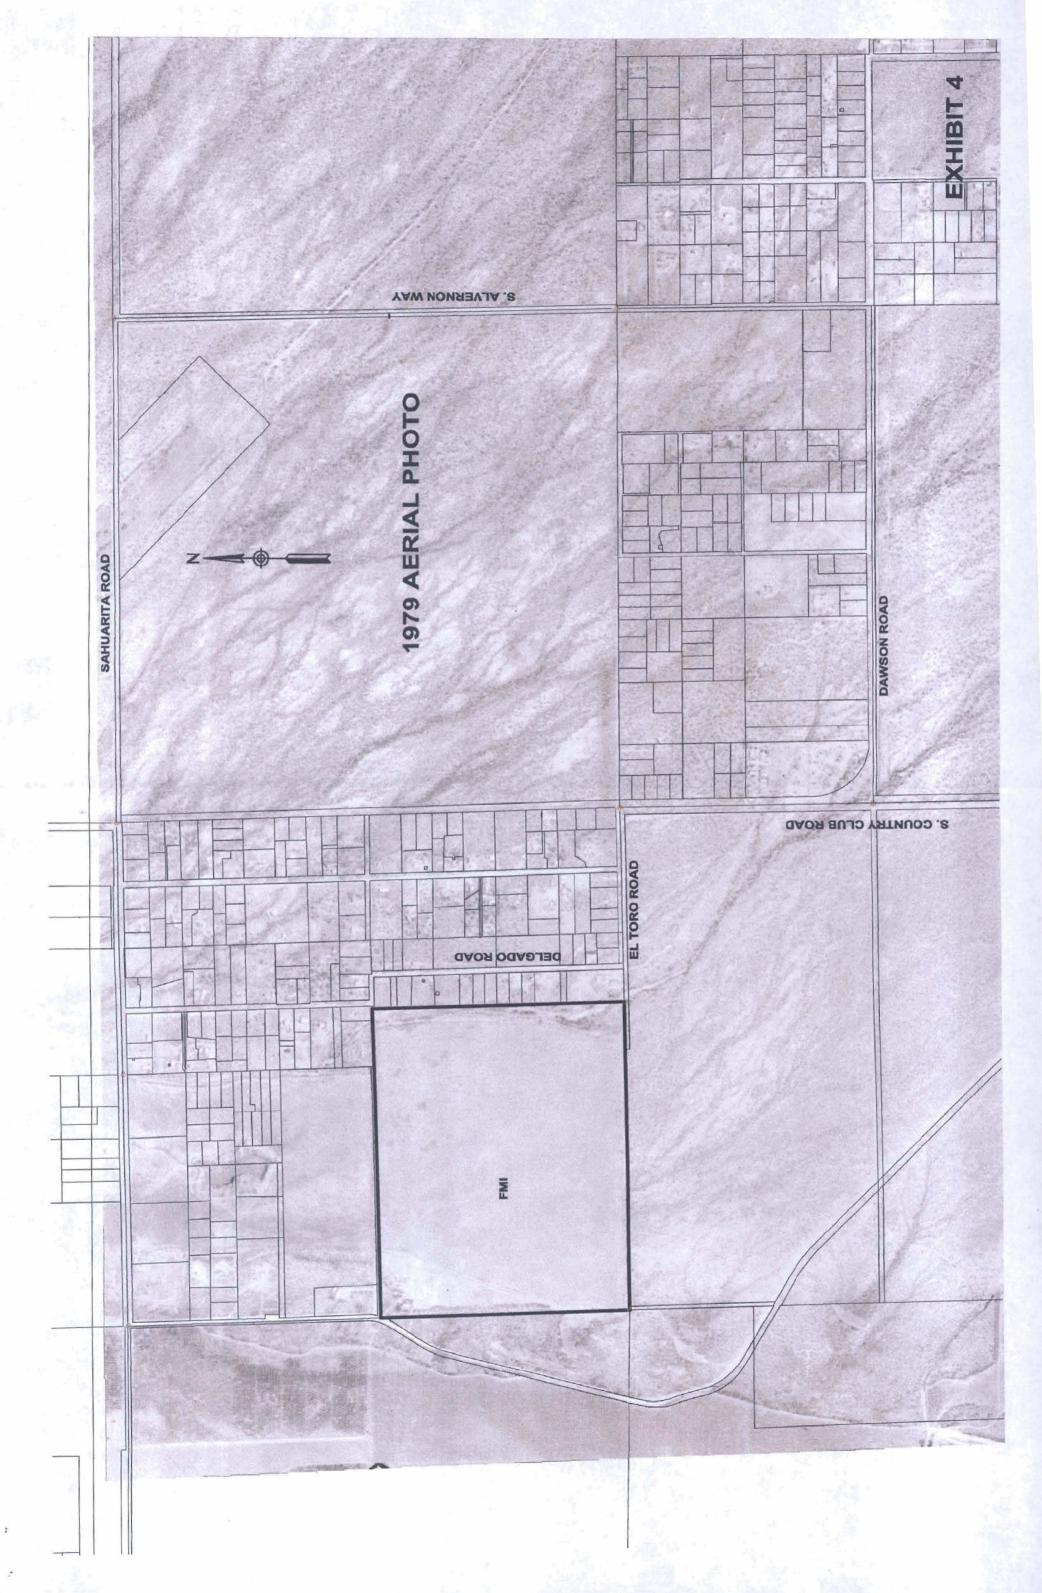
Exhibits 4 and 5 are aerial photographs from 1979 and 2005. Exhibit 4 (the 1979 photo) clearly illustrates the modification of the natural drainage pattern including the cut off of flow from the farm field (present FMI property) and the concomitant formation of the south to north "Main Drainageway" along the back side of the Delgado Road properties. This cutoff was also evident in a previous aerial photo covering a portion of the subject area from 1974 although no earlier aerial coverage from the 1950s or 1960s was available to more precisely document the reported 1950s construction date of that Main Drainageway. Exhibit 5 (the 2005 aerial coverage) illustrates the most recent photograph and most closely represents the present condition of the subject area.
